EPSON Product Support Bulletin

Date:	April 2, 2007	Originator:	VS
PSB #:	PSB.2007.04.001	Authorization:	<i>[Signature]</i>
Reference:	TI 06-0491 Rev.B	Total Pages:	2
Product(s):	Expression 10000XL/1640 XL/1680/1600/800/836 XL, Perfection 3490/3590/4490/V700/V750/V100/V350/1240U/1250/1260/1640/1650/1660/1670/2400/2480/2580/3170/3200/4180/4870/4990/640U/1200U/610, GT-2500/15000/30000 series scanners		
Subject:	Scanning Application Force Quits on Mac OS 10.4

Date:	4/2/2004	Originator:	TC
PSB #:	PSB.2004.04.002	Authorization:	<i>Kps</i>
Reference:	N/A	Total Pages:	2
Product(s):	Perfection 3200 Series Scanner		
Subject:	LaserSoft Imaging™ SilverFast® Driver issues with Windows 2000 and XP

Date:	9/18/2003	Originator:	TC
PSB #:	PSB.2003.09.001	Authorization:	Kas
Reference:	N/A	Total Pages:	2
Product(s):	Perfection 3200 Series		
Subject:	Updated Epson Scan v. 1.21A for Macintosh OS 10.2.x

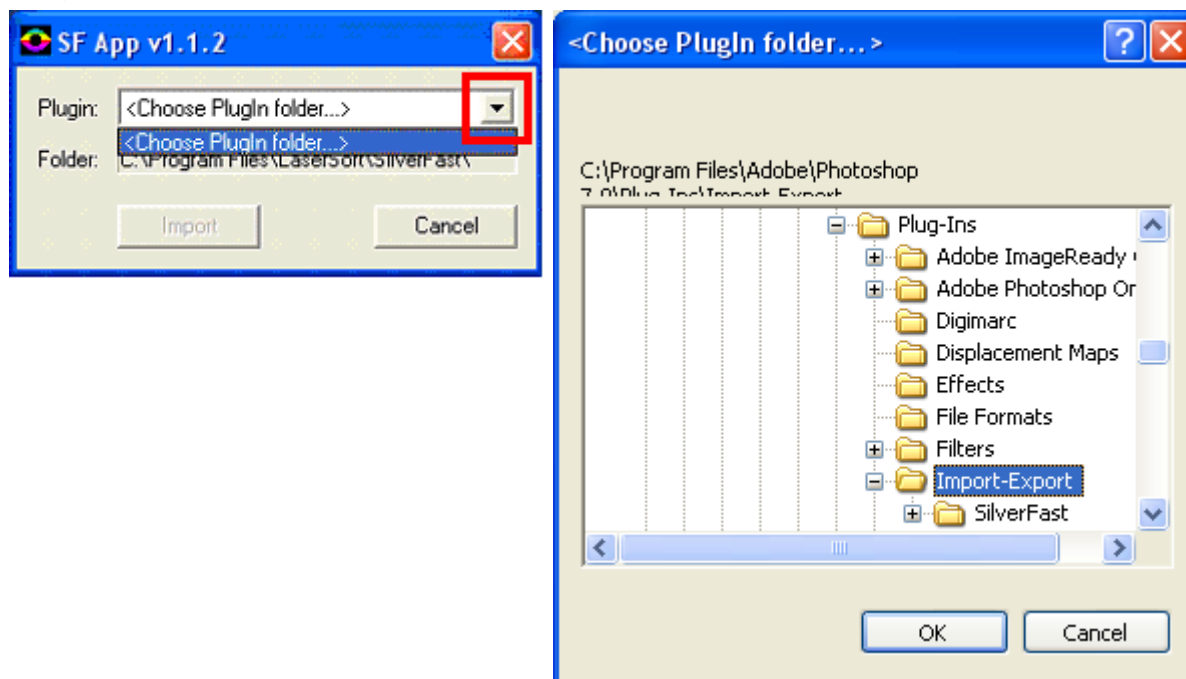
When the SilverFast scanning application (SF App v1.1.2) is first launched you see the following screen. You must click on the Drop-Down button (see red box) in order to be able to choose a PlugIn folder.

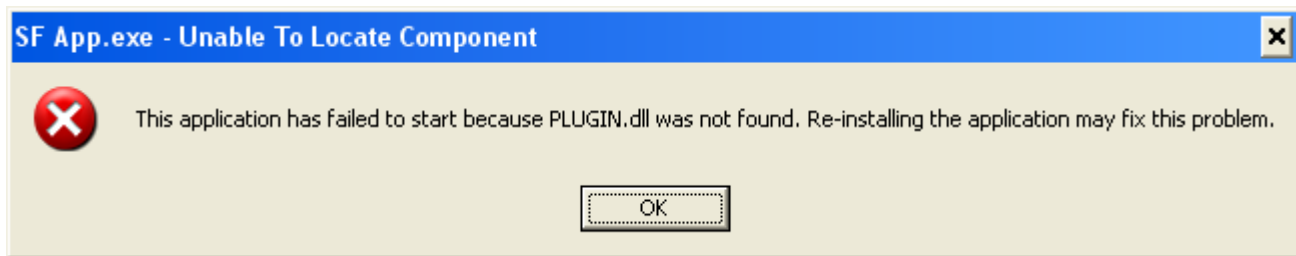
Next, if you click on the "Import" button in Windows XP, you will see the following error message:

This occurs because the "Plugin.dll" file does not get copied to the Windows "System32" folder.

- #1) Manually copy the Photoshop Elements "Plugin.dll" file to the Windows "System32" folder.
 1. If you have installed Photoshop Elements 2.0 in the default location, the Elements "Plugin.dll" file can be found in: "C:\Program Files\Adobe\Photoshop Elements 2." Open "My Computer" and navigate to this folder. If you did not use the default folder, then navigate to the folder you selected or created for Photoshop Elements 2.
 2. Copy the file and then navigate to your Windows "System32" folder. The Windows "System32" folder can be found in the Windows Operating System folder. Typically it will be "C:\Windows\System32" or "C:\WinNT\System32." Then paste a copy of the Plugin.dll file into the "System32" folder. This will prevent the Plugin.dll error from occurring.

#2) The second way to resolve this error is to upgrade the version of SilverFast. Follow the download and installation steps outlined below.

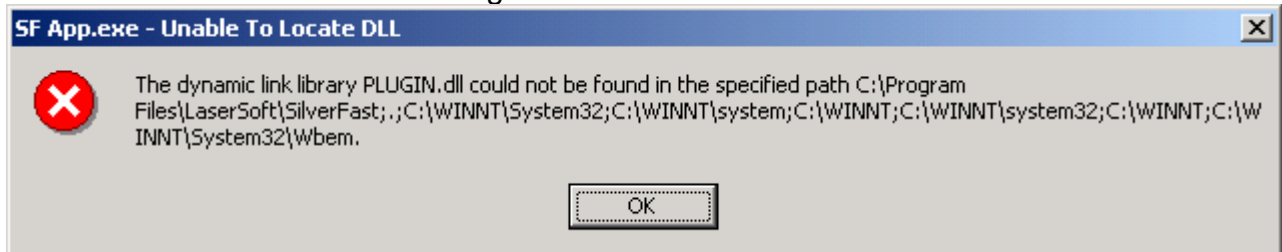
in Windows 2000 the error message looks like this:

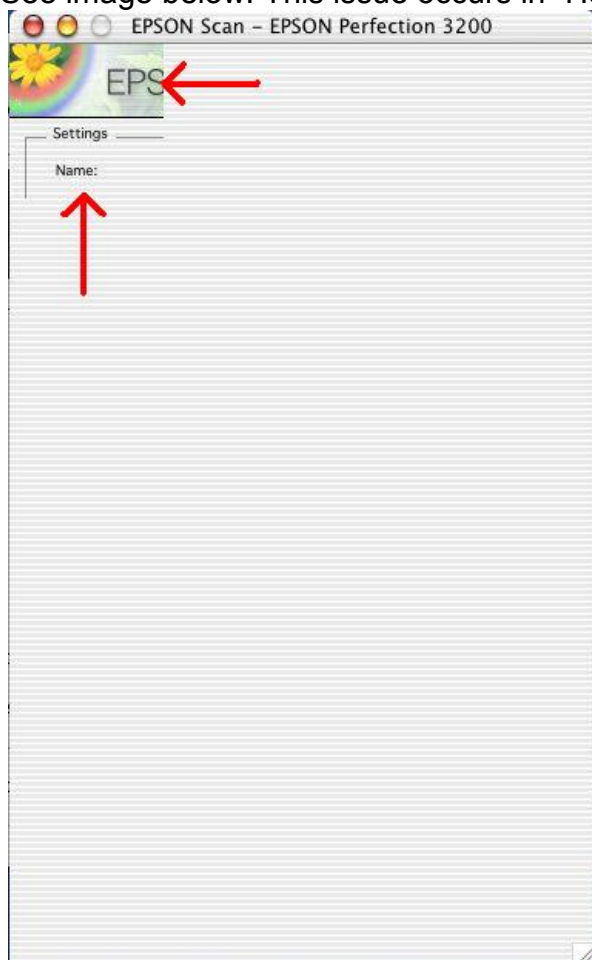
When scanning with Epson Scan Driver v.1.21A in ArcSoft PhotoBase v. 2.5 in OS 10.2.x, the Epson Scan user interface screen does not refresh itself properly after a scan. Instead, the user interface window displays as a blank except for a 1" x 1" square in the upper left-hand corner. See image below. This issue occurs in "Home" and "Professional" modes.

Comments: This problem does **not** occur in the other two ArcSoft Suite applications (Panorama Maker 3.0 and PhotoStudio 4). The issue does **not** affect Adobe Photoshop Elements 2.0, or any

other TWAIN compliant applications. In Epson Scan's Professional Mode, if you grab the "resizer handle" (located in the lower right-hand corner) and resize the user interface window, the window will refresh itself properly.

A patch is now available. Go to ArcSoft's PhotoBase Support page at:

<http://www.arcsoft.com/en/support/downloads/patches.asp?title=8> to download and install the patch file. If this link is not working, visit ArcSoft's website at: <http://www.arcsoft.com/en/index.asp> and navigate to the PhotoBase support Page to find the patch file. If you have questions about your ArcSoft product contact ArcSoft's Technical Support at (510) 440-9901 or fax them at (510) 440-1270.

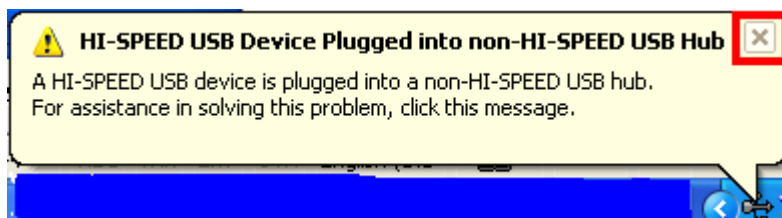
This bulletin was created to inform you of a Windows XP warning message that comes up when an EPSON HI-SPEED USB (USB 2.0) scanner is connected to a non-HI-SPEED USB (USB 1.1) Port. The message is only an indication that Windows XP recognizes a USB 2.0 scanner connected to a USB 1.1 port. This warning message appears the first time the scanner is connected to the computer, and every time the scanner is powered on. It is NOT an error message. The message cannot be disabled, but you can close it by clicking on the "X" as shown in the red box below.
